# Morphological Analysis of Apical Foramen Over-instrumented by Three Rotary NiTi Systems

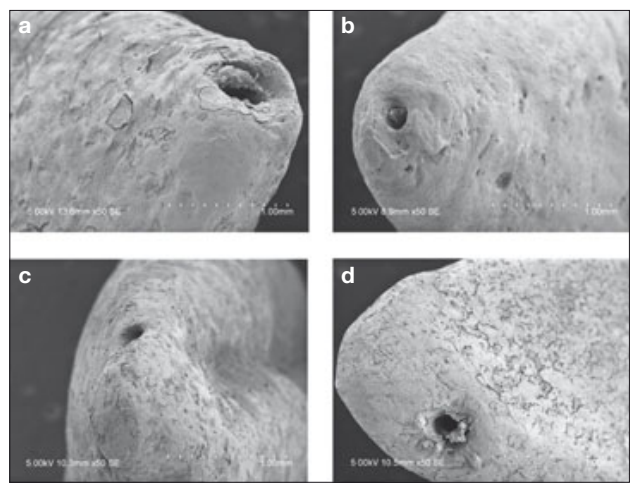
**Fig 1** Foramen-centred and foramen-deviated group. Major foramen in the center of their root tips (a, c); foramen-deviated group with deviations of the major foramen >0.5 mm from the root apex (b, d).

Extracted human maxillary central incisors were selected after examination under stereomicroscopy (XT-III, Jiangxi KongFungYi Technology Company) under 20 × magnification to exclude any cases with preexisting craze lines and cracks. In order to eliminate the influence of curvature factor on experiment results, the curvatures of the teeth between 0° and 8° were included. When the distance from the centre of their root tips to the major apical foramina was above 0.5 mm, it was regarded as a foramen-deviated tooth, otherwise, it was regarded as a foramen-centred tooth. Seventy foramen-centred and 70 foramen-deviated teeth were included as Group A and Group B, respectively. In each group, 20 teeth were randomly assigned for preparations with PTU files (Dentsply Maillefer, Ballaigues, Switzerland), K3 files (SybronEndo, Orange, CA) and TF files (SybronEndo, Orange, CA), respectively; the remaining 10 teeth were used as the control group without any

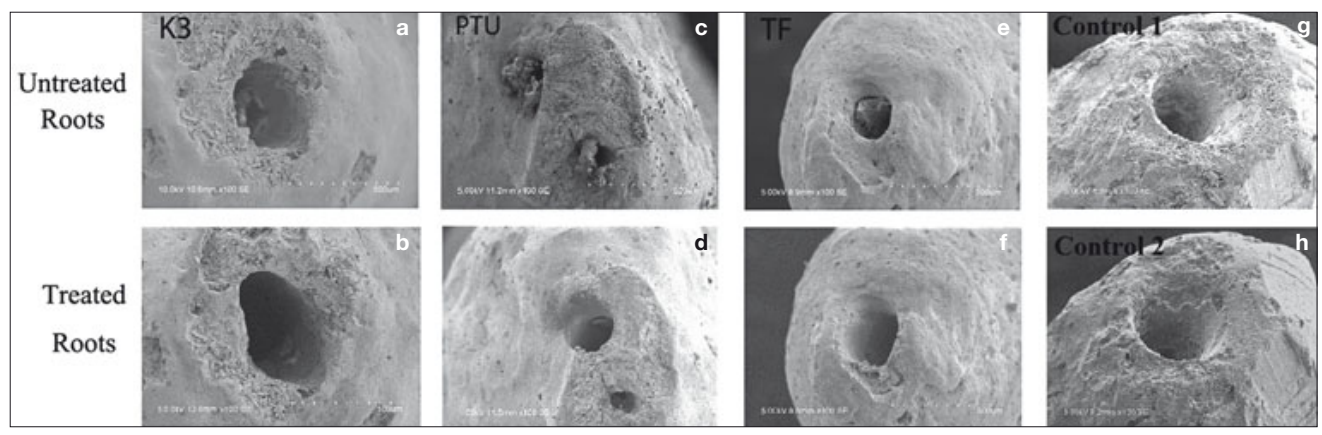
**Fig 2** SEM of the apical foramen morphology before (a,c,e,g) and after (b,d,f,h) preparation with K3, PTU, TF files.

then prepared for SEM imaging similarly after instrumentation. Three pre- and postinstrumentation images for each sample centred on the apical foramen with different angles were taken.

The integrity damage of the apical foramens and the presence of dentin defects were defined by comparing the baseline image of each root with the postinstrumentation images of the same root. Foramen integrity damage (FID) was evaluated and determined when more than one-third circumference of the apical foramen was damaged by nickel-titanium rotary files or other external forces. Dentin defects (DDs) include any cracks, detachment and fracture of tooth structure around the apical foramen as described in previous studies<sup>12,13</sup>.

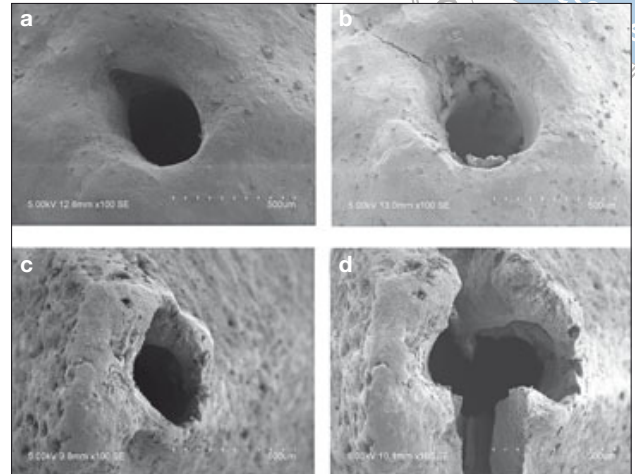
**Fig 3** Dentin defects in foramen-centred group (a, b) and in foramen-deviated group (c, d).

fracture susceptibility.<sup>14,15</sup> In the current study, even with a larger root, there were significant cracks (dentin defects) noted when the canals was overinstrumented, however it was highly significant when the foramen was deviated especially for the stiffer K3 files and to a slightly lower extent the larger tapered PTU files.
